PHRT Feb. 7, 2023 Letter to U.S. EPA
Enclosures

DOCUMENTATION OF AMINE REPAIRS

AMINE UNITS ADVISIAN RECOMMENDATIONS TRACKING REPORT

Port Hamilton Refinery and Transportation LLLP

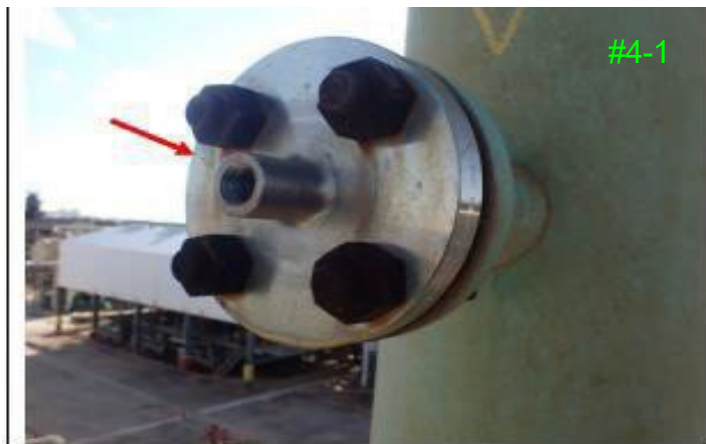
#4-1

-The **Before Photo (#4-1)** shows the missing 1-1/2" plug at the Thermowell No. 325, located at the 10" inlet line of the Amine Coolers E-4833

Missing Plug

Item	Advisian Recommendations	Description	P&ID	Action	Completion Date	Comments
No. 4 Amine Unit						
1	Install missing 1-1/2" plug on Thermowell (325) / Line #4830-011-C-10	Install missing 1-1/2" plug on Thermowell No. 325 /Line No. 4830-011-C-10"	4830-D-0002 Sht. 2 of 5	A new 1-1/2" plug was installed	1/2/2023	This item is complete. Please reference the attached photos.
2	Tightened loose blind flange	Loose drain valve wheel tagged DRN 4-4 Line No. 4830-ME-614- BK1-8"	4830-D-0002 Sht. 1 of 5	Tightened drain valve wheel	1/2/2023	This item is complete. Please reference the attached photos..
No. 5 Amine Unit						
1	Monitor 6" section of piping with wrap / evaluate at the next unit turnaround	6" piping section wrap at the shell-side inlet of E-5831A (Amine Still Reboiler) requires evaluation prior to the next turnaround. Line No. 5830-015-B-IH-6"	5830-D-0002 Sht. 3 of 5	This process line section was taken out of service, isolated (isolated by valves/chain locked closed). The system is isolated and will be inspected prior to the next T/A. The line segment will be closely monitored (via scheduled field verifications) by Operations with status updates documented by log entry.	1/4/2023	This item is considered complete, until next T/A. Please reference the attached photos.

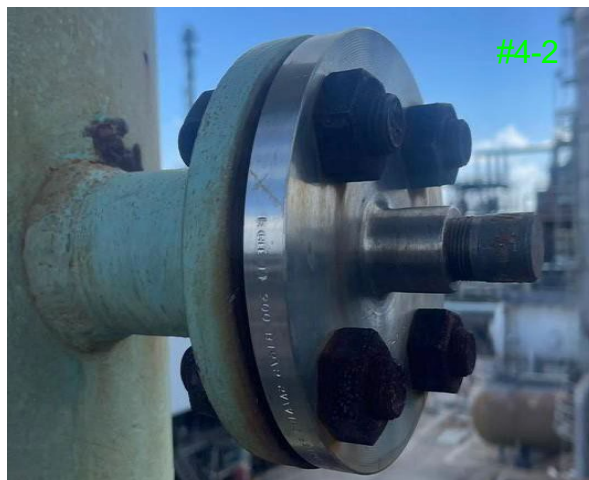
#4-2

-The **After Photo (#4-2)** shows a new 1-1/2" plug installed at the same Thermowell to ensure process containment

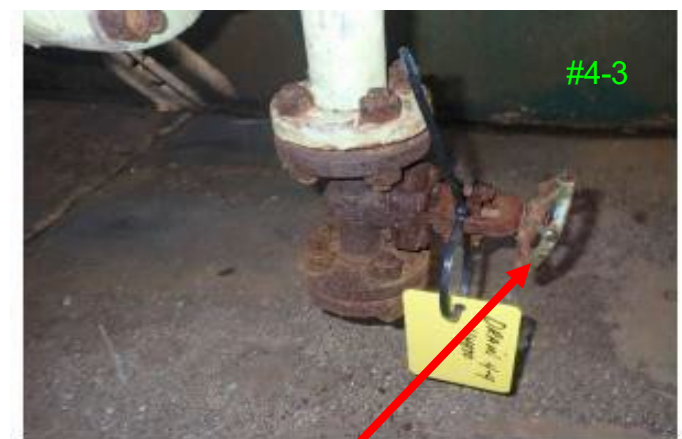
#4-3

-The **Before Photo (#4-3)** shows the loose drain valve wheel, located at the drain piping of the Rich Amine Flash Drum D-4831

Loose drain flange (4-4)

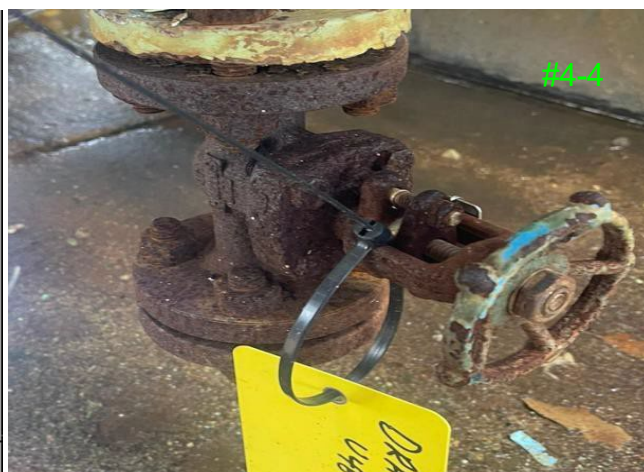
#4-4

-The **After Photo (#4-4)** shows the same drain valve wheel tightened and checked by Maintenance for functionality

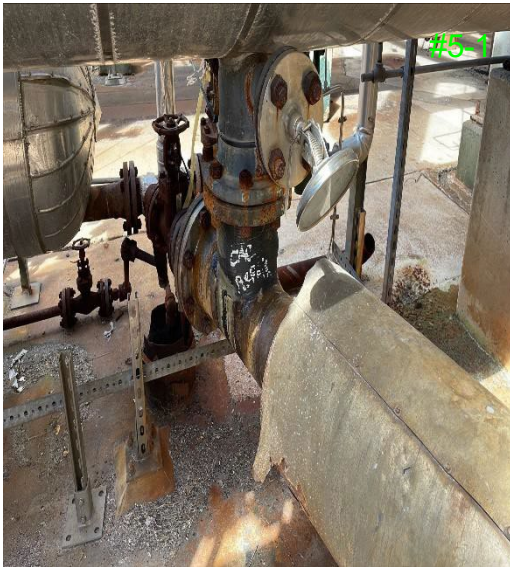
-The photo #5-1 shows the wrapped section of pipe located at the E-5831A (Amine Still Reboiler) shell-side inlet and the drain valve that is closed

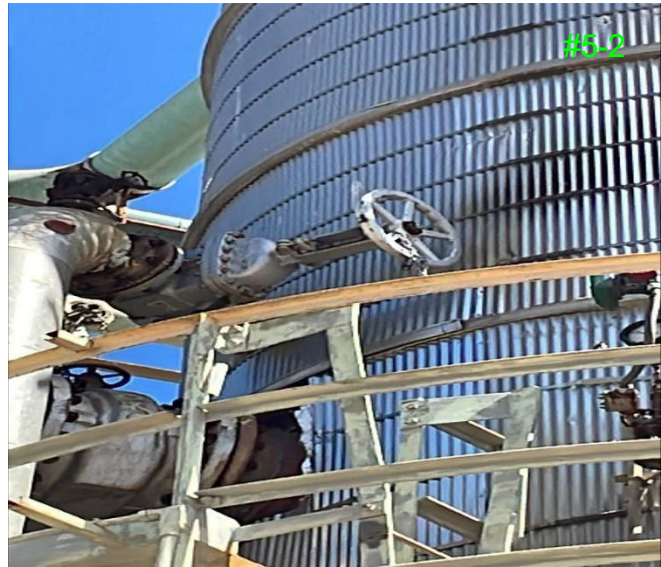
-The photo #5-2 shows the 8" valve located at the Amine Still Draw Line To Reboiler Inlet that is isolated and chain locked closed

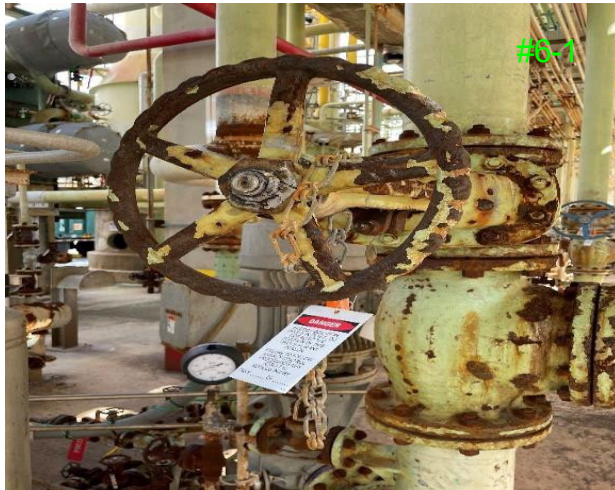
P-7453 A DISCHARGE

-The photos #6-1 & #6-2 show the discharge and suction lines isolation valves at the P-7453A Pump (isolated and chain locked closed)

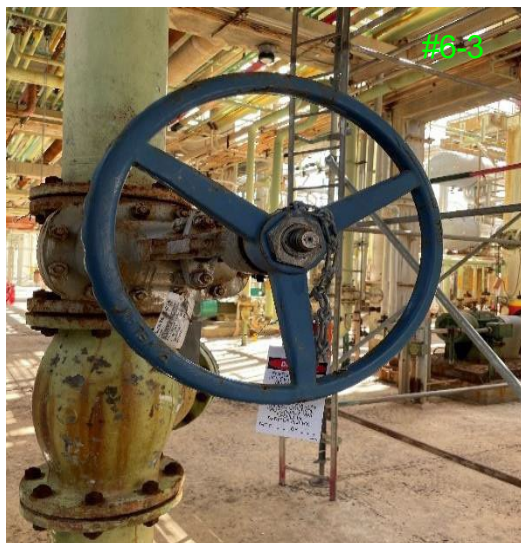
P -7453 B DISCHARGE

-The photos #6-3 & #6-4 show the discharge and suction lines isolation valves at the P-7453B Pump (isolated and chain locked closed)

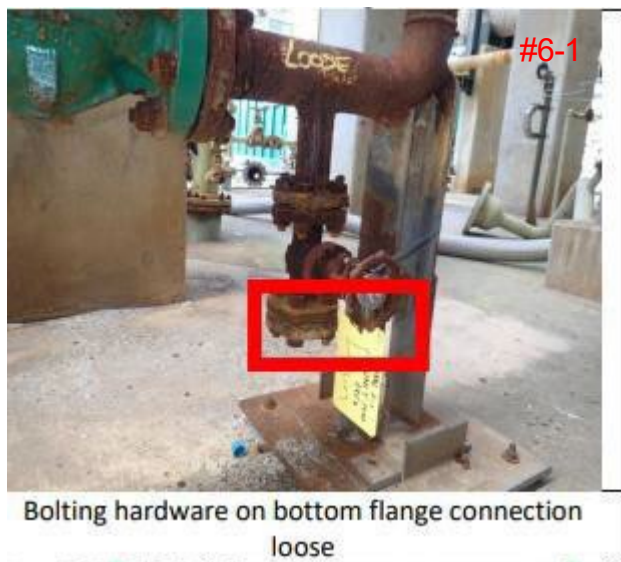
-The Before Photo (#6-1) shows the loose btm blind flange at the drain tagged DRN-2-1, located near LV-5118

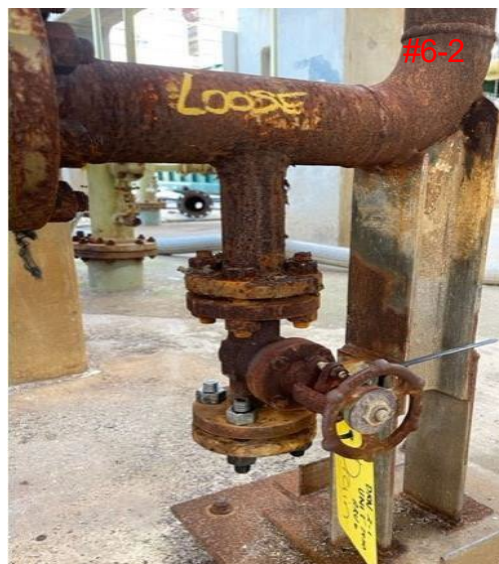
-The After Photo (#6-2) shows the same btm drain flange fitted with new bolts, gasket, and tightened

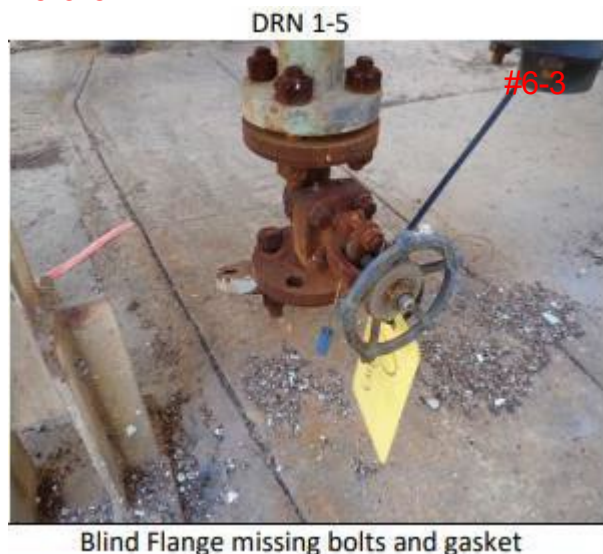
-The Before Photo (#6-3) showing the btm drain valve flange not properly installed, located near TV-5046B

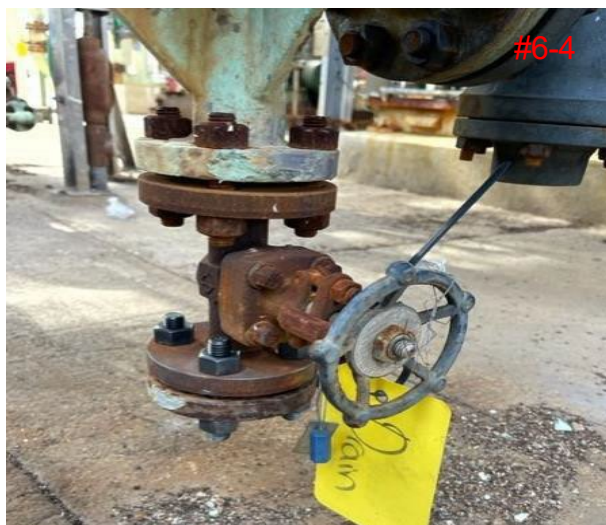
-The After Photo (#6-4) showing the btm drain flange properly installed, new bolts, new gasket, and tightened

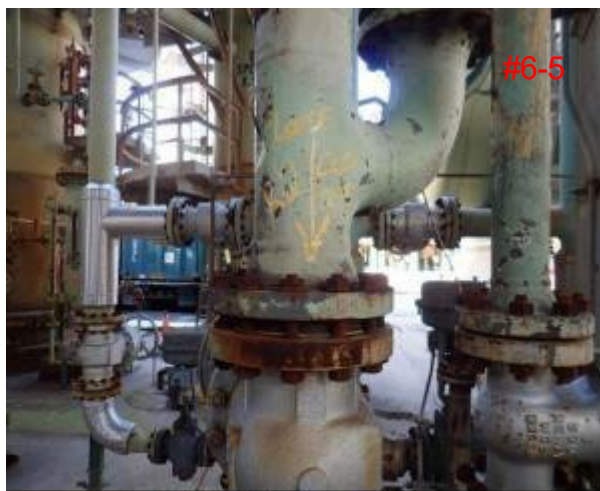
-The Before Photo (#6-5) shows loose bolts at the 6" pipe flange located near the Transfer Pump P-7459

Bolting Hardware Loose

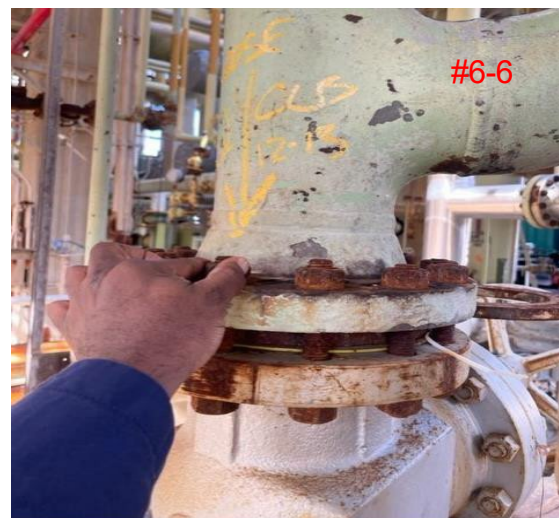
-The After Photo (#6-6) shows the bolts tightened (Maintenance personnel also shown hand- checking bolts)

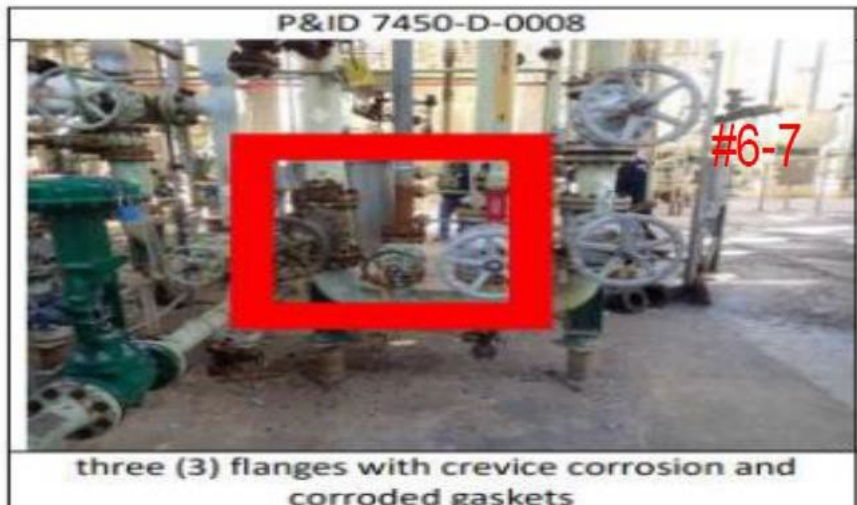
The pictures shown below (#6-7 thru #6-9) illustrate photos corresponding to Item #3 of the N.o6 Amine Unit Advisian Recommendations. The reference P&IDs showing the 6" pipe flanges are 7450-D-0007 & 7450-D-0008. Before Photo #6-7 below shows flange identified by Advisian as having crevice corrosion.

3	Disassemble identified flange connections with crevice corrosion, mechanical clean the flanges, and replace the corroded gaskets	Piping surfaces identified with corrosion Two (2) 6" lines (1)-upstream of ISO 5-2 tag and (1)-downstream of tag CV-5 . Crevice corrosion was identified, (2)-6" flanges and one (1)-3" flange downstream of tag CV-5 .	7450-D-0007 7450-D-0008	Disassembled flange connections with crevice corrosion, mechanically cleaned the flanges, replaced all corroded gaskets and the line systems were isolated.	1/13/2023	This item is complete. Please reference the attached photos.
4	Filter (F-7453) – Monitor corrosion on (3" and 1") nozzles / Evaluate at the next unit turnaround	Corrosion on two (2) nozzles (3" and 1") nozzles located near the Filter F-7453 /evaluate at next unit turnaround (T/A)	7450-D-0009	The line segments associated with these nozzles (1" and 3") have been removed from service and isolated (isolated by valves/chain locked closed). Continued monitoring of the nozzles is not required.	1/4/2023	This item is considered complete, until next T/A. Please reference the attached photos.

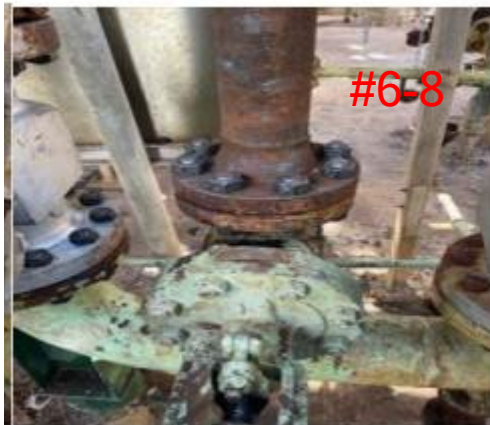
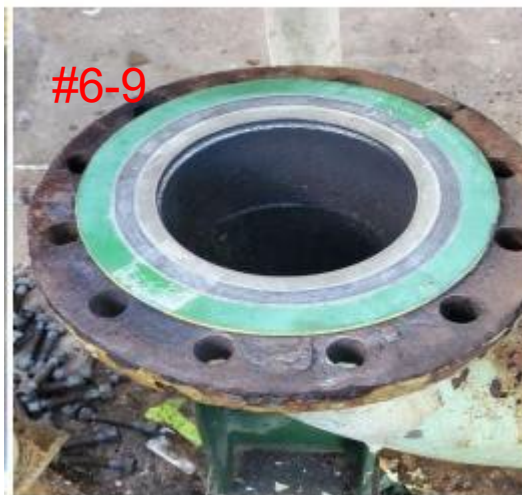
-After Photo #6-8 & #6-9 shows the flanges with crevice corrosion mechanically cleaned, their gaskets replaced. The line systems were isolated to prevent potential leaking.

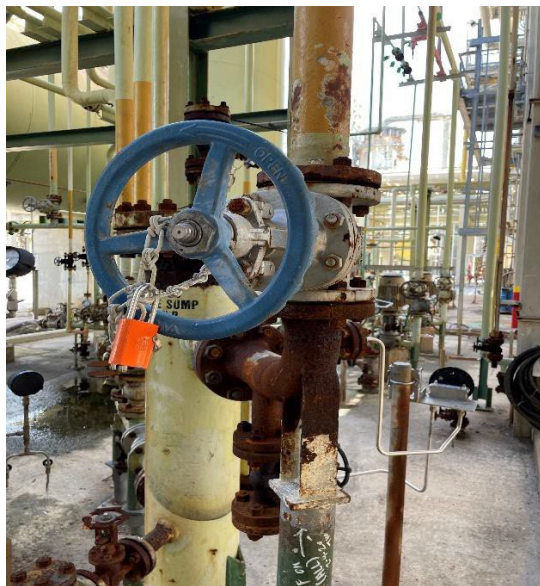
F-7453 Outlet - #6-10

-The photo #6-9 shows the Filter F-7453 outlet isolation block valve chain locked closed

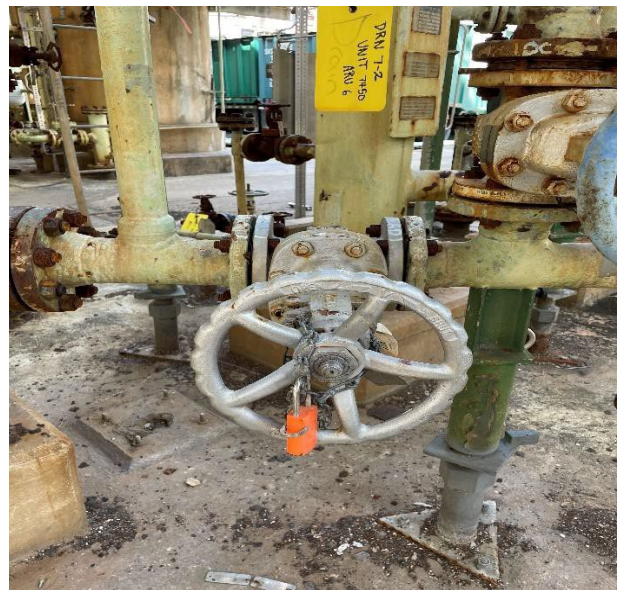
F-7453 Inlet - #6-11

-The photos #6-10 shows the Filter F-7453 inlet isolation block valve chain locked closed

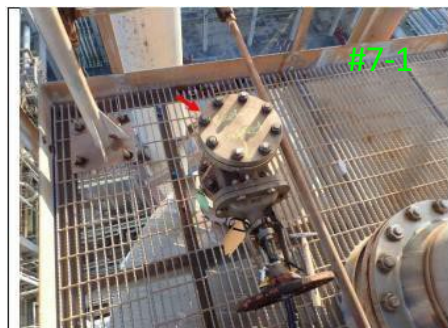
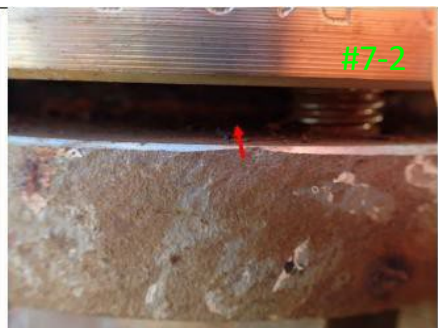
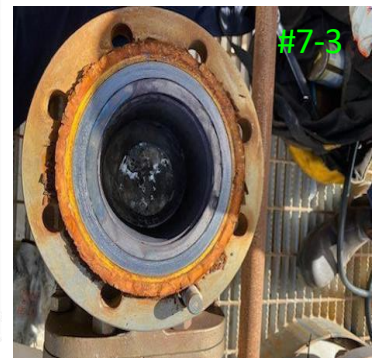
- The **Before Photos show the 4" vent valve, corresponding blind flange on the top the Amine Regenerator Tower T-7461 (#7-1), and its corroded gasket (discarded) (#7-2 & #7-3).**
- The **After Photos show the same vent flange cleaned (#7-4) and a new gasket fitted between the valve and the blind flange for adequate leak protection (#7-5).**

No. 7 Amine Unit						
1	Disassemble 4" vent flange at the top of T-7461 tower , mechanically clean and replace corroded gasket	The gasket between the 4" valve and blind flange on the top head of T-7461 vent was degraded.	7460-D-0008	Disassembled 4" flange at the top of Tower T-7461, mechanically cleaned, and replaced the corroded gasket.	1/4/2023	This item is complete. Please reference the attached photos.
